WATERCARE MINING

## Case Study: Replacing Municipal Drinking Water with Watercare Mining-Treated Waste Mine Water

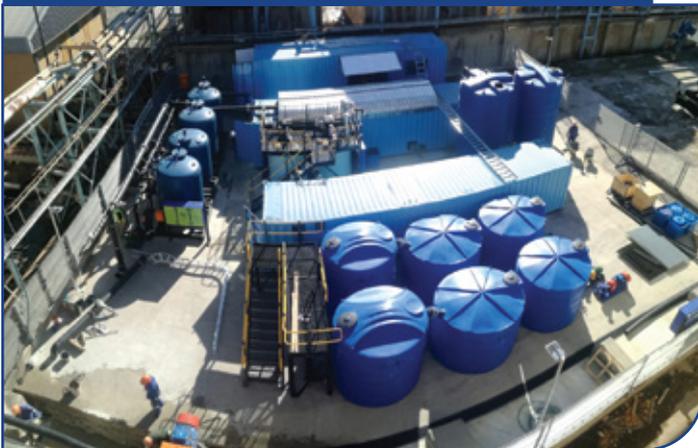
FIGURE 1: NYALA WATER PLANT

Watercare Mining designed, built and commissioned a water plant to treat 2 900 ML/day of mine return water to produce SANS 241:2015 potable water at a recovery of 70% (volume based). The water treatment plant comprises sand filtration, ultrafiltration, reverse osmosis (RO), disinfection and remineralisation. The backwash water and RO brine is diverted to the mine's tailing system.
